## *Service Tips – 30RB Chillers*

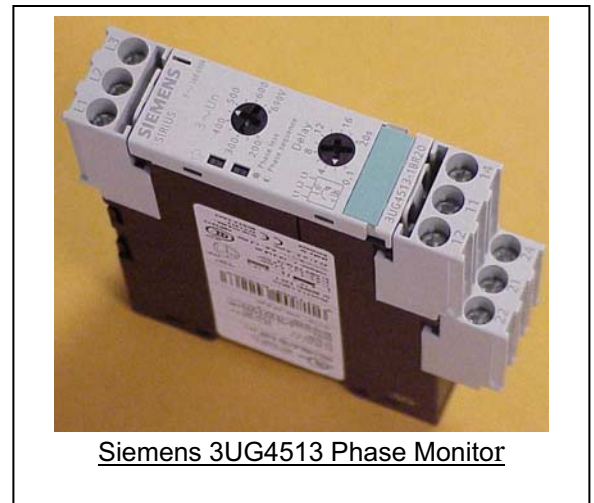
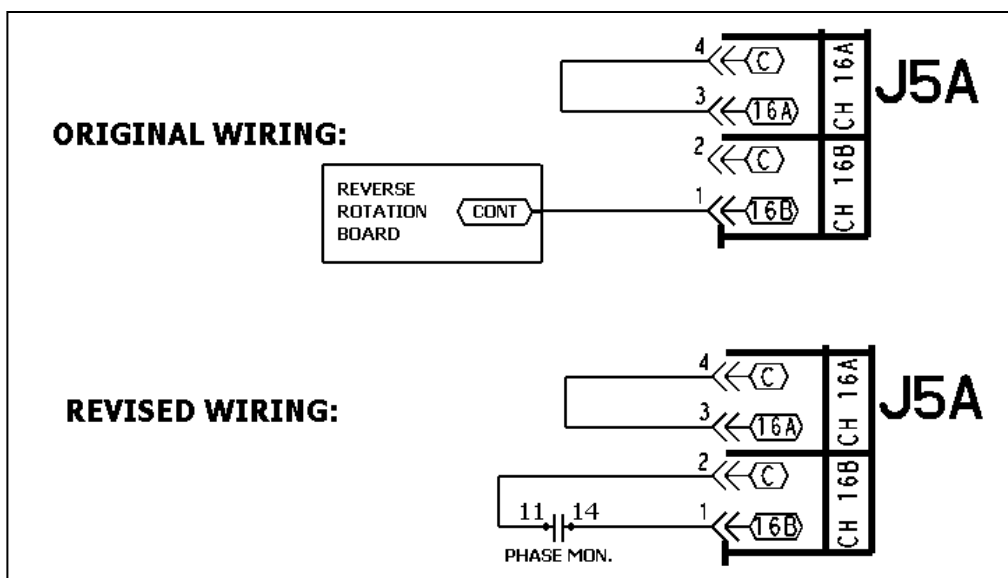
- This alarm indicates that the Reverse Rotation Board (RRB) contact is open. (The confusing description comes from the fact that, in Europe a thermostat is required in the power enclosure, and there the RRB is in the same circuit.) The 24vac feedback to MBB J5A terminal 16B is absent when checked.

- Other notes on the original RRB (HK35AC003, CEPL130444-03):
  - It is not really suitable for 575 volt applications, so it may (but not certainly) be damaged by the line voltage.

- This RRB may not protect the unit in the case of single phasing of the compressors. In this case it has been observed that a back emf fools the RRB such that it does not trip.

- The new/replacement RRB will be Siemens phase monitoring relay 3UG4513-2BR20, implemented into factory production starting with 4006 (week 40 of 2006). RCD has or will have the new relay under part #30RB680036. See figure. This relay is DIN-rail mounted. Wire the relay to the MBB as shown below (across N.O. contacts 11-14).

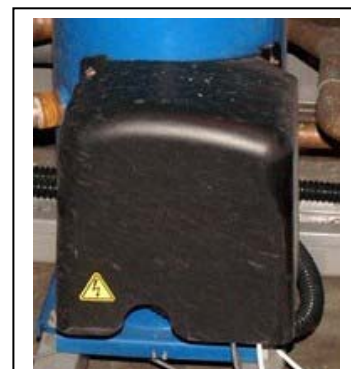
Basic Cover

- Original covers exhibited a high incidence of cracking, especially at the upper corners (“ears”).
- Refer to bulletins SMB 06-0024, SMB05-0032B, and SMB 05-0029B for more details.
- Root cause of the cracking has been traced to:
  - The plastic material was incompatible with oils, including compressor oil and condenser coil fin die lubricant. Contact with oils will permit residual stresses in the plastic to become cracks quickly.
  - The studs on the compressor were not originally located to be perfectly compatible with the placement of the matching slots in the covers.
- The rotating plastic clips had problems, too: Clips originally had plastic pivots. Clips and pivots broke easily.

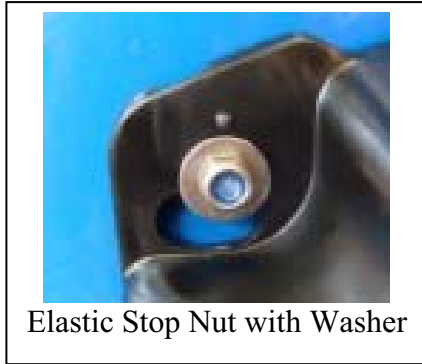
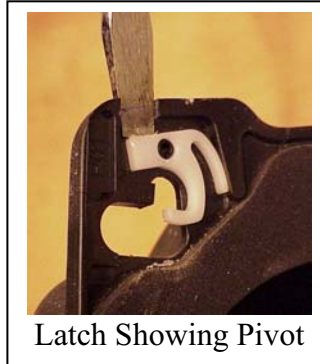
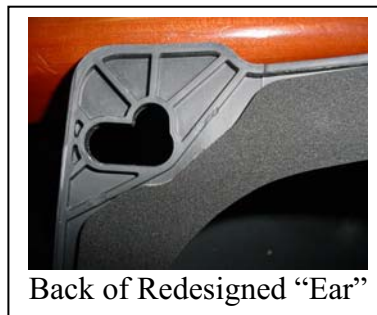
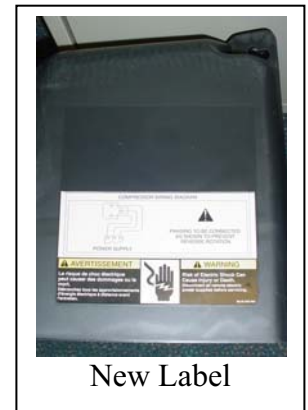
- These covers have undergone several design changes and stages since the original.
  - In mid-2005 the Carrier factory added wide washers and elastic stop nuts to fasten the studs.
  - The plastic clips were retained, but the pivots were changed to metal.

- In early 2006 the basic plastic material was changed, the clips were eliminated, and the slots and ears were redesigned.
- The new design covers were available from RCD beginning the week of April 24, 2006. The part numbers will not change from the original.
- Final replacement is covered by SMB06-0024 which includes a Warranty Policy.

- The new/final cover design can be distinguished from the earlier ones by (a) strengthening ribs behind the upper attachment slots and (b) the label on the right side of the cover which does NOT describe how to attach and remove the cover (half the height of the original labels). See photos above.

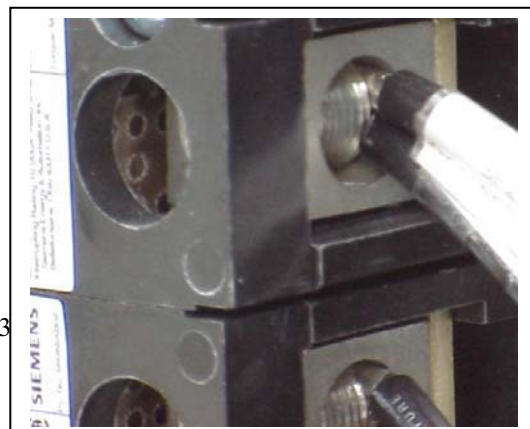
- For some 208/230 volt machines (especially units made prior to 3805), compressor circuit breaker wires were not tight. Lug screws seemed to strip when tightened.

- Root cause was that the breaker lug screws were too short for the combination of large breaker and small wire size.
- The remedy is to replace the lug screws with longer screws. Refer to SMB05-0054 for details.
- Note: There is no charge for replacement lug screws, but you will have to pay for replacement lugs.

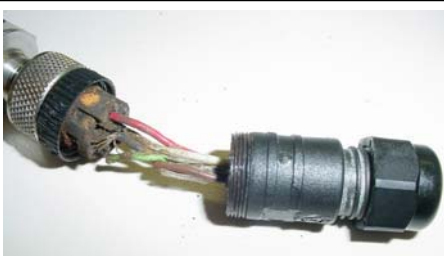
- At the cable connection approximately 12” from the EXV or flow switch some connectors have been found to be corroded, resulting in a poor electrical connection. The root cause is a poor seal where the cable enters the connector.

Corroded EXV Cable Connector

- The field fix is to replace the connector and coat the terminals with dielectric grease. The RCD kit number is 30RB660012.
- The factory is replacing these with a molded M12 connector, as shown in the picture to the right.

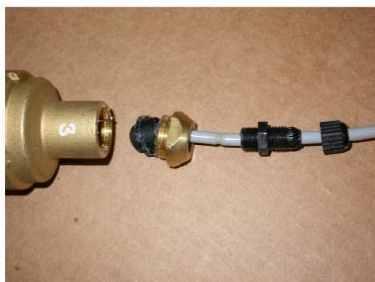
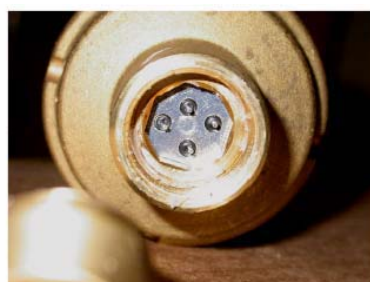
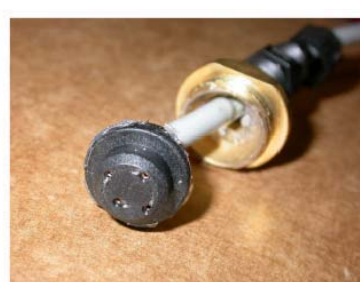
- There have been a few reports of EXV motor failures, traceable to electrical terminal failure inside the EXV motor assembly.
- The root cause is that, in the manufacturing process, not enough time was allowed for potting to set.
- Beginning with production date 0906Q (approximately), a completely new sealed pin design was implemented to address this issue. See pictures below.

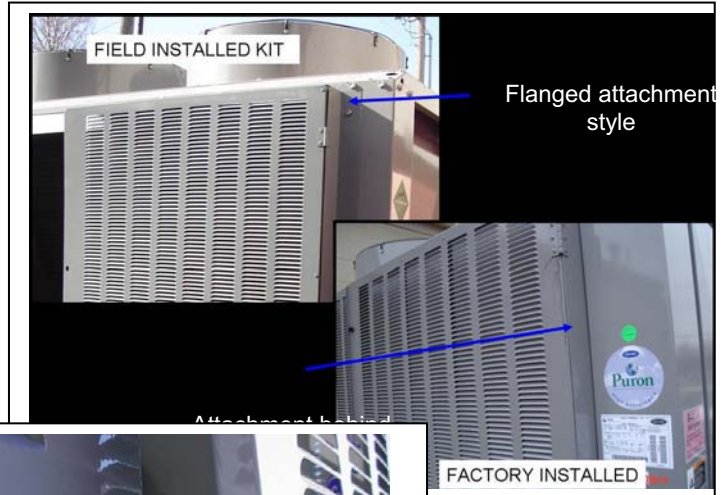
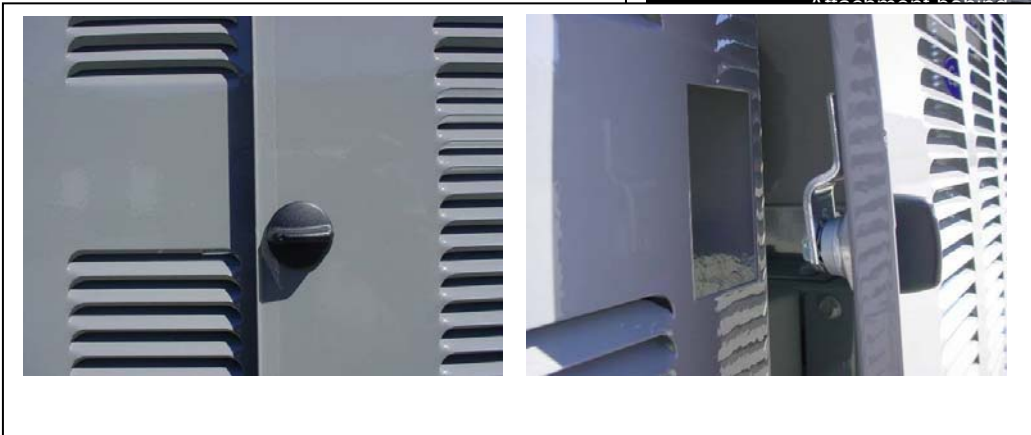
- There have been reports of plastic latches on hail guards breaking. These were Southco part HARHPL-3-1-1.

- Unit design has been changed to use metal latches (starting with production week 0606). Unfortunately, these latches are not interchangeable (the cutouts in the panels are different). The metal latches are shown below.
- Through early 2005 hail guards were provided as field-installed accessories, and some were made with a flange attachment style (below). This design was replaced by the design with the attachment behind the corner post (right).

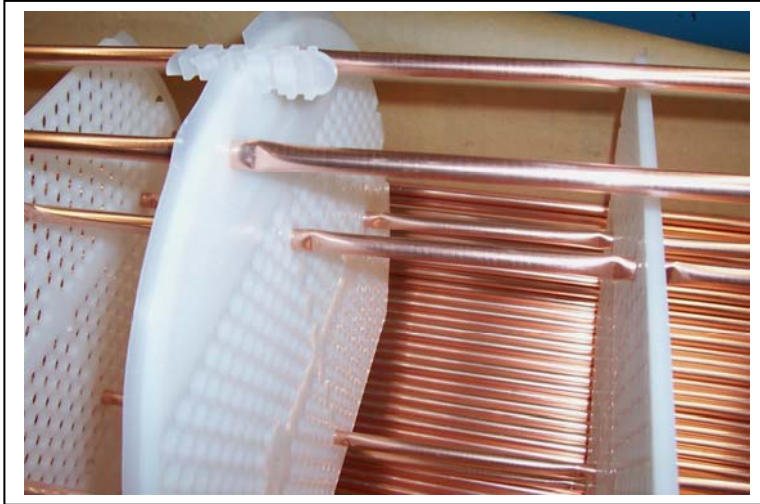
- When inspecting the cooler tube bundle from the water inlet or outlet nozzle, you may see several pinched off tubes, as shown in the picture below (taken at our factory in Monterrey, Mexico). This is intentional, and these special tubes serve to locate the baffles within the bundle. These tubes do not extend through the tubesheets.
