## *Service Tips – 30RB Chillers*

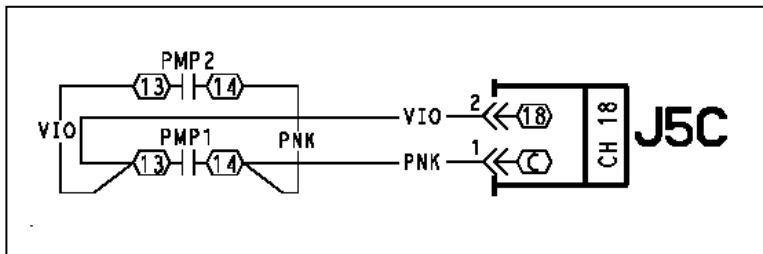
- If you want the chiller to control external water pumps, you *must* wire pump auxiliary contacts (feedback contacts) to MBB J5C (CH 18), *not* to TB-5 terminals. Find pink and violet wires in wire trough. Failure to do this will result in [P.32](#) or [P.33](#) pump failure alarms

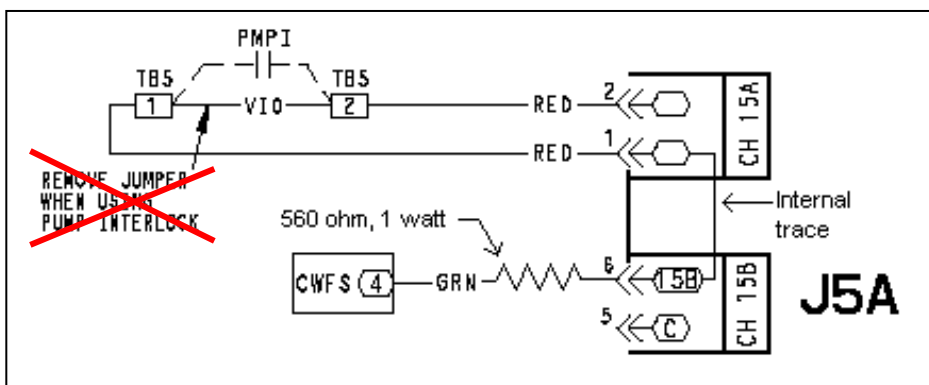
- Generally you will *not* use anything across TB5 1-2 except the factory provided jumper. If an auxiliary contact is added here, it must be *in addition* to the auxiliary used at J5C Channel 18 shown above. This is different from 30GX/HX and 30XA usage of TB5 1-2. (But if you *do* add an extra auxiliary contact between TB5 1-2, yes, you do have to

remove the jumper as the note says.

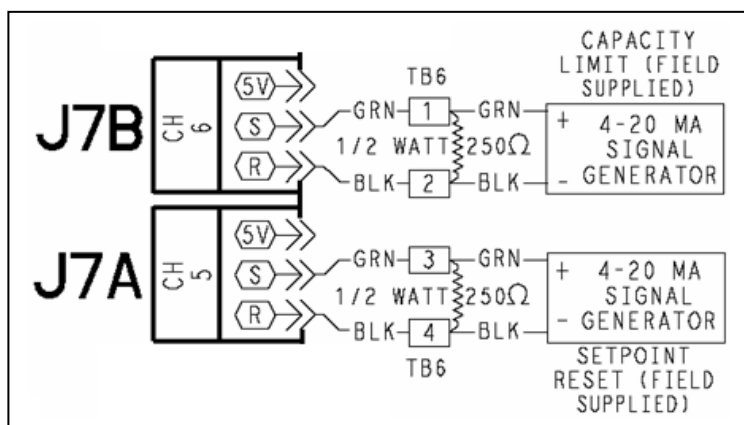
- Energy Management Board (EMM) analog inputs are used for (a) chilled water reset or auto setpoint, and (b) demand limit.
- The inputs are "advertised" to be for 4 to 20 mA current sources. When used with such a current source, a 250Ω resistor must be installed across the input terminals as shown in the diagram. This resistor converts the current to a 1 to 5 dcv input, which is what the

EMM board really looks for.

- For field-installed EMM boards, the resistors must be field-supplied and installed. As of this writing, with factory-installed EMMs the resistors are not being supplied either. So check for this, and expect to install the resistors.
- If the customer prefers to use a dc volt input, it may be applied across the same terminals. Make sure that the operating range of the customer's input is set up to provide 1 to 5, not 0 to 5 volts. Note that a dc volt input should work whether or not the 250Ω resistor is in place. In the configuration set **Setpoints > COOL > CRV1** to **4** (mA equivalent to 1 volt with the 250Ω resistor) and **Setpoints > COOL > CRV2** to **20** (mA equivalent to 5 volts).
- A 2 to 10 dcv input source may be used if an extra resistor is added to make a voltage divider. (See example below.)

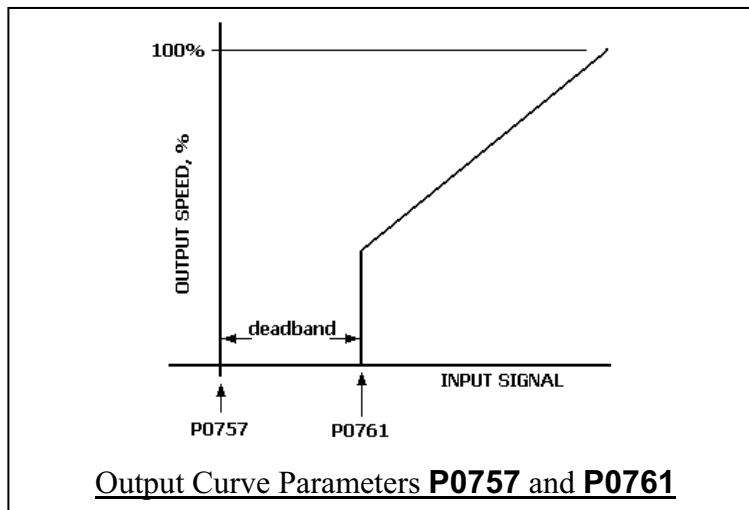
▶ Set Offset **P0757** & **P0761** to **0.50** (volts). This will result in no fan speed with voltage noise up to 0.5 volts. See the figure below.

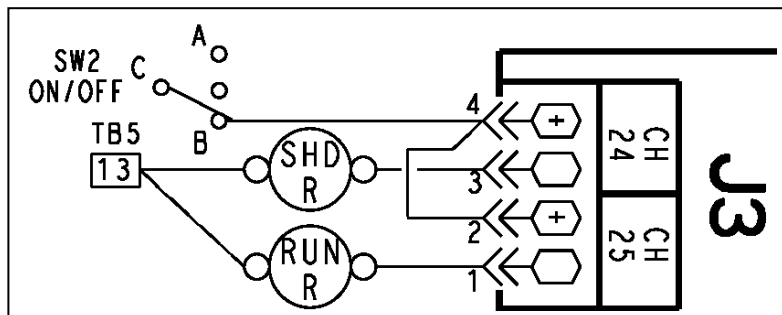
- This output is on J3 of the optional EMM (Energy Management Module) board. See Figure for wiring. (Terminal plug for J3 is RCD part no. 734-104.)
- Output will not work unless the “hot” 24vac connection is field wired from switch SW2 to J3-4, and the jumper between J3 pins 2 and 4 is added.

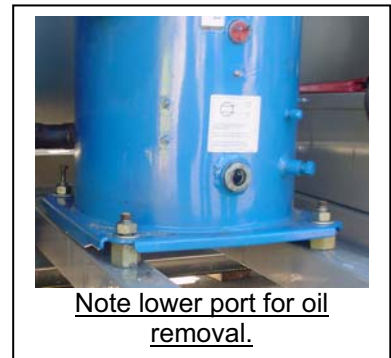
- Fill out the compressor failure report form. Return it to  
**TSI Warranty Department**
- In order to facilitate removal of excess oil from the system after replacing a compressor, the kit now includes a Schrader valve for installation in the lower oil port on the side of the compressor. (See figure.) From the factory it is fitted with an NPT pipe plug. The addition of the Schrader valve permits oil removal without pumping down the circuit (to less than 5 psig).

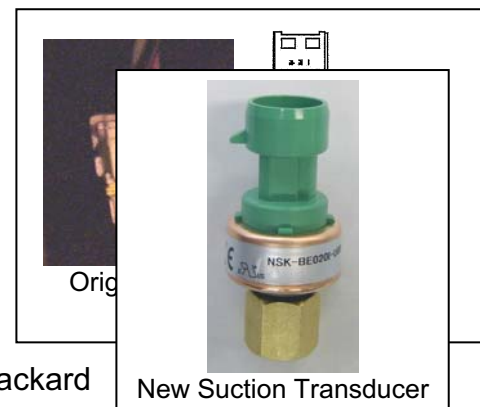
- 30RB pressure transducers are made by Danfoss (Saginomiya), not Texas Instruments as with prior models. Suction and discharge transducers are different, and they are identifiable by different body colors. Refer to the chart below.
- The original 30RB transducers used a connector style (shown on the right) which proved to be difficult to disconnect. In some cases the wires could be accidentally pulled out of the cable side connector when trying to separate the connector parts. The connector was different from the Packard Electric style typically used on earlier Carrier chillers.
- Starting with production week 5005, the transducer connectors were changed to the more familiar Packard

Electric Style. These and their associated cables have different part numbers and body colors as shown in the following chart.
